## **Subsea Transmission Link**

Sicily to Calabria, Italy

To monitor and protect the overland sections of this important link, AP Sensing's fiber-optic based DTS (Distributed Temperature Sensing) solution was selected.

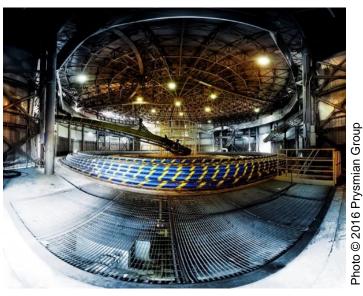
Cable produced in Arco Felice, Italy

Central phase monitored

**Two 8 km Linear Power Series DTS devices,** each with 2 channels and 44 relays, were installed in a **single-ended configuration** to monitor the temperature of the central phase of 2 circuits of power cable. The power cable itself is a **double-circuit 380 kV HVAC system**.

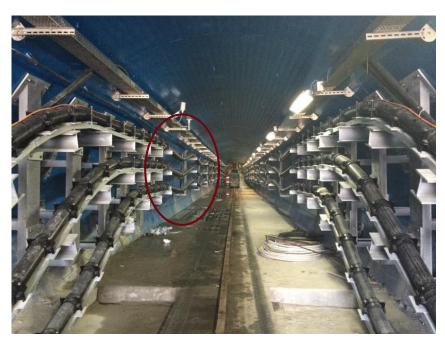
Power circuit through tunnel with sagging

Power cables in general suffer from strain caused by the operation of the cable. To minimize the unwanted strain effect, the cables were installed with some slight sagging at intervals (see the photo below). Furthermore, a DTS device based on Raman technology is used for temperature monitoring, which is insensitive to strain-crosstalk.

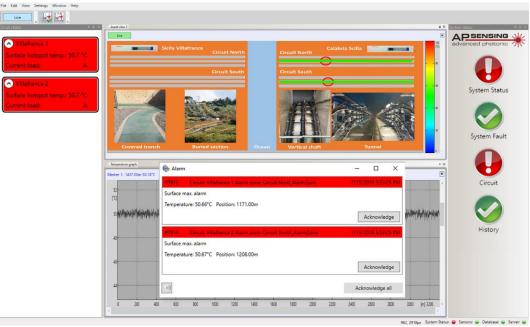
SmartVision overview screen

The installation was further enhanced with our SmartVision information management suite. SmartVision provides a color-coded asset visualization of all circuits in one overview. Temperature graphs and hotspot tables are always available and accessible. SmartVision also offers reporting and analysis capabilities, a central database and alarm management features. During the SAT (system acceptance test), test alarms were generated by placing thermoresistors in both of the circuits. All criteria for all tests were met successfully.

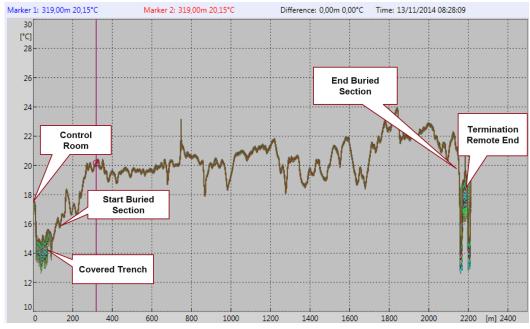
Results of temperature traces showing different setup sections, e.g., Control Room, Buried Sections, Trench and Terminations.

SmartVision temperature trace

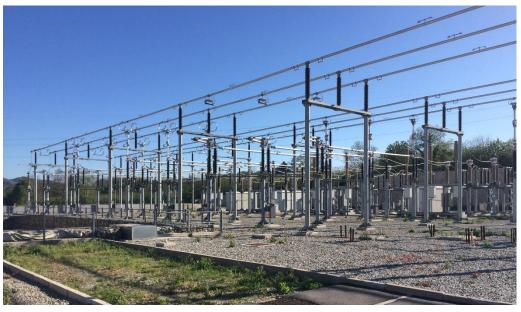
High voltage power cables
