Fault Localisation with Distributed Acoustic Sensing (DAS) – Service Experience

Rasmus **OLSEN**; Ørsted Wind Power, (Denmark), raaol@orsted.dk

Simon **STEFFANSEN**, Kristian **OLESEN**; Energinet Transmission, (Denmark), ssv@energinet.dk, koe@energinet.dk

Rosalie **ROGERS**, Gareth **LEES**; AP Sensing, (Germany), rosalie.rogers@apsensing.com, gareth.lees@apsensing.com

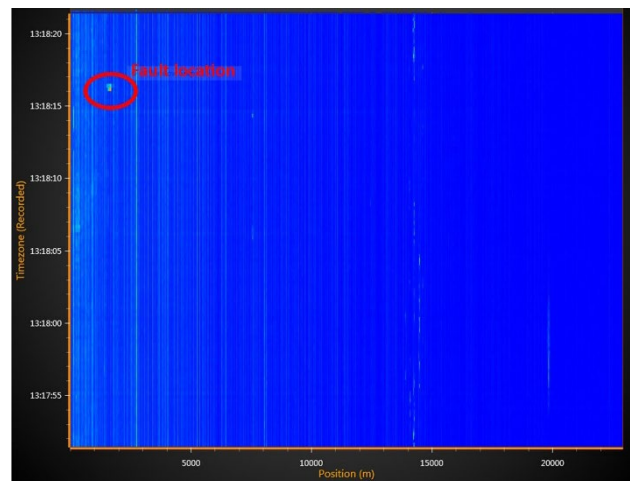
By thumbing the cable with the impulse generator, it was found that it required 28 kV before a flashover could be generated, however at that point the fault location was also clearly shown on the DAS, as seen in Fig. 6.

Fig. 6: Waterfall diagram showing the intensity of the acoustical signal along the cable as a function of time. The fault location is clearly seen, and the geographical position was identified by walking along the cable which could be followed on the DAS system.

This case study proves that by proper calibration and adjustment of the equipment, easy fault pinpointing is possible by using DAS. Furthermore, it is shown that even a fault with a limited fault energy of 5 kJ, as in this case, is very noticeable in the DAS waterfall diagram if properly setup. A real fault where an entire transmission grid is delivering energy to the fault will be even more noticeable, and it will therefore not be problematic to locate faults even in the phases furthest away from the fibre optic cable.

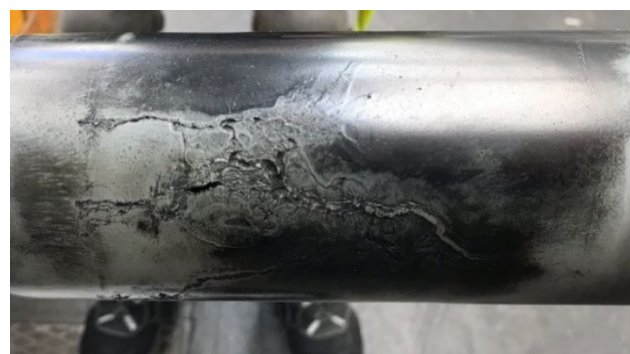
By sending a man walking along the cable, it was possible to get a geographical pinpointing of the fault, to perform the excavation at the correct location and, as shown in Fig. 7, it was correct that the joint was faulted, and a flashover had occurred. Also for this fault, the personnel had to rely on the DAS data for fault localization as no visual signs were noticeable on the outside of the joint.

Fig. 7: Fault location inside the joint. It is clearly seen that the fault was located correctly even though it was not possible to visually confirm on the outside of the joint.

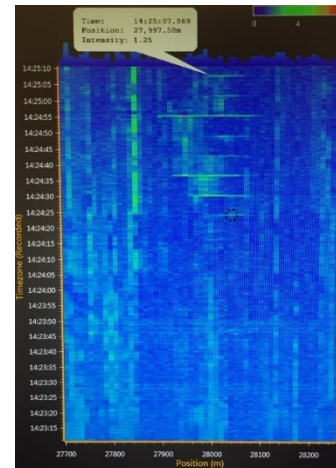
The resolution of the DAS therefore had to be set to the maximum of 50 meters and careful monitoring of the waterfall diagram was done by skilled personnel from the TSO. The results were clear and a zoom on the 500 meters closest to the acoustical signal is shown in Fig. 9.

Fig. 9: Waterfall diagram showing the intensity of the acoustical signal along the cable as a function of time. The fault location is seen at 28040 m even though it is not so explicit as case study 2, Fig. 6. The resolution is not as high as elsewhere in this paper as the cable length was 90 km.

It is clear from this that the cable fault should be found around 28020 meters from the measurement unit.

It is important to remember that Fig. 9 shows that even on a 90 km cable it is possible to get very close to pin pointing the fault, as the fault indication is within 50 meters and that this can be geographically coordinated by walking along the cable and making noise.

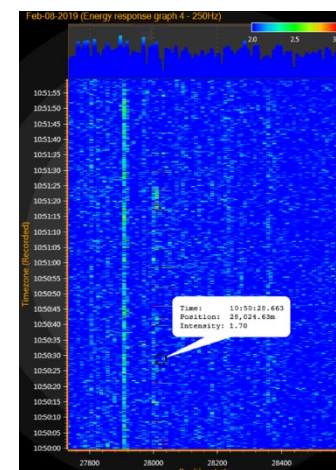
In this case study a further pinpointing was done, to get even closer to the location, by measuring the step potential. During this step potential measurement, the DAS unit was optimised to a 20 meters resolution around the fault location which was also a success, and it was possible to correlate the movement around 28000-28020 meters on the ground with the flashover site, as shown in Fig. 10.

Fig. 10: Waterfall diagram showing the intensity of the acoustical signal along the cable as a function of time. The data presents someone walking on the cable around the fault location. This served as geographical correlation between the DAS fault data and the geographical position of the fault.

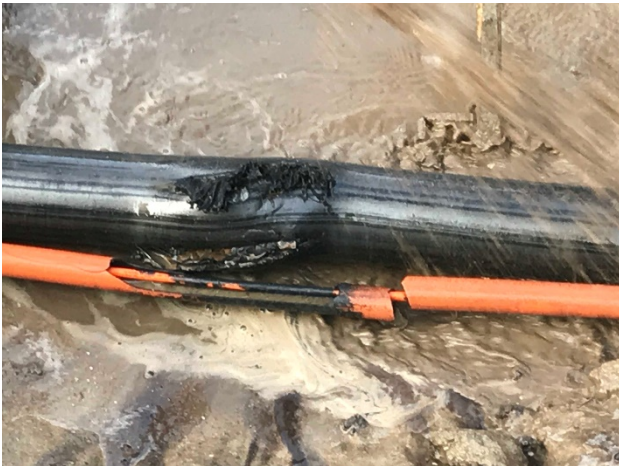
As seen in Fig. 11 the DAS pinpointing was also correct in this case.

Fig. 11: Fault location. It is clearly seen that the fault was located correctly.
