Bus Duct Temperature Monitoring in a Hyperscale Facility

United Kingdom/United States of America

Project Overview

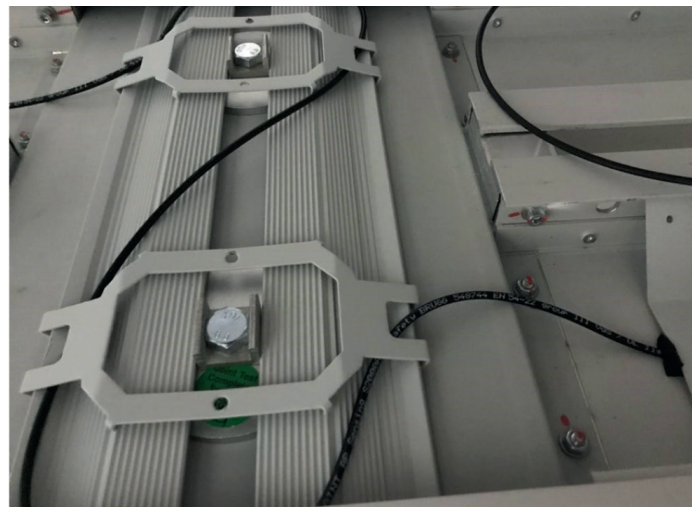
Figure 2: Sensor Cable on E&I 3200A bus duct joint

AP Sensing collaborated with a local partner for the deployment of one fiber optic Distributed Temperature Sensing (DTS) unit with four channels; each channel monitors up to approximately four kilometers. Due to physical space constraints, the DTS unit is wall mounted and fitted within an electrical room. The fiber optic sensor cable was fitted along the 1600A and 3200A ampacity bus ducts, including at all joint areas, using custom cable clips. Joint temperature monitoring is particularly important for high ampacity bus ducts. Our DTS solution is configured for Modbus TCP/IP
