# Optical Fault Location and Temperature Monitoring of a 220 kV Power Cable

## Denmark

The “Horns Rev 3” offshore wind farm, located off the west coast of Denmark, has a maximum installed power capacity of 400 MW. The operators wanted a monitoring solution to locate cable faults immediately after they occur. They chose AP Sensing for our unique combination of DTS (Distributed Temperature Sensing) and DAS (Distributed Acoustic Sensing) capabilities.

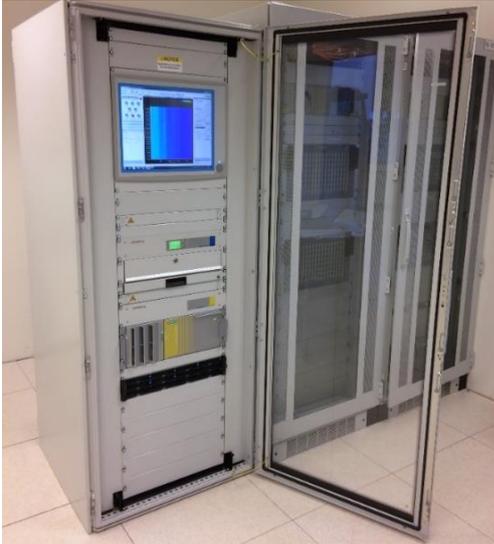
**Fully integrated rack solution with DTS, DAS and SmartVision™ in the control room**

The optical fault location system consists of three DAS systems, including a single-channel DAS interrogator, a DAS data acquisition unit, and a storage unit each. Two DAS units are located in Blåbjerg and one in Endrup. All have a 40 km measurement range. The temperature monitoring system consists of 2 DTS units. The first is in Blåbjerg with two channels and a 50 km measurement range. The other DTS unit is located in Endrup with four channels and a 30 km measurement range. The free channels are allocated for upcoming projects.

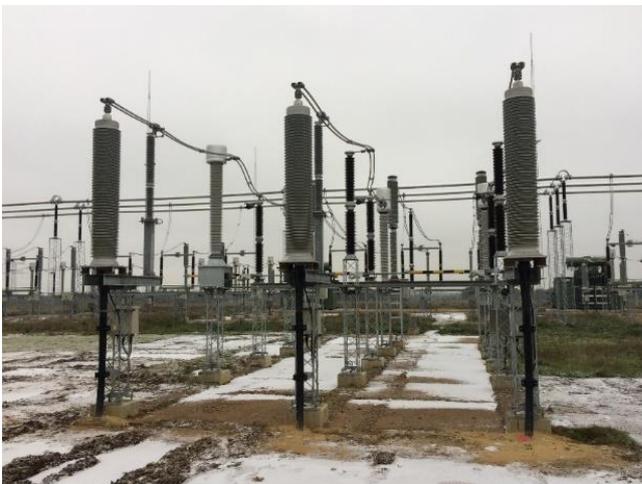
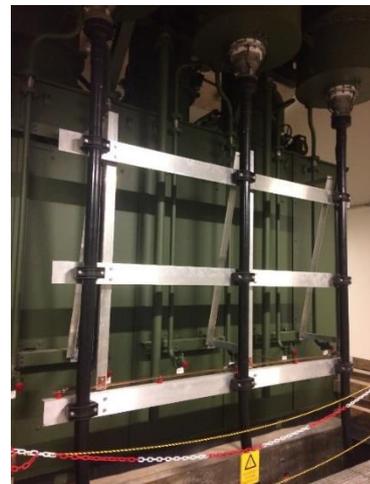
**Installations at project site**
