Dam Leakage Detection and Monitoring

Knezevo Dam, Macedonia

A rockfill dam with an asphalt core in Macedonia required leakage detection and seepage monitoring. AP Sensing provided a monitoring solution using our partner GTC Kappelmeyer's fiber optic leakage detection method alongside an AP Sensing Distributed Temperature Sensing (DTS) device.

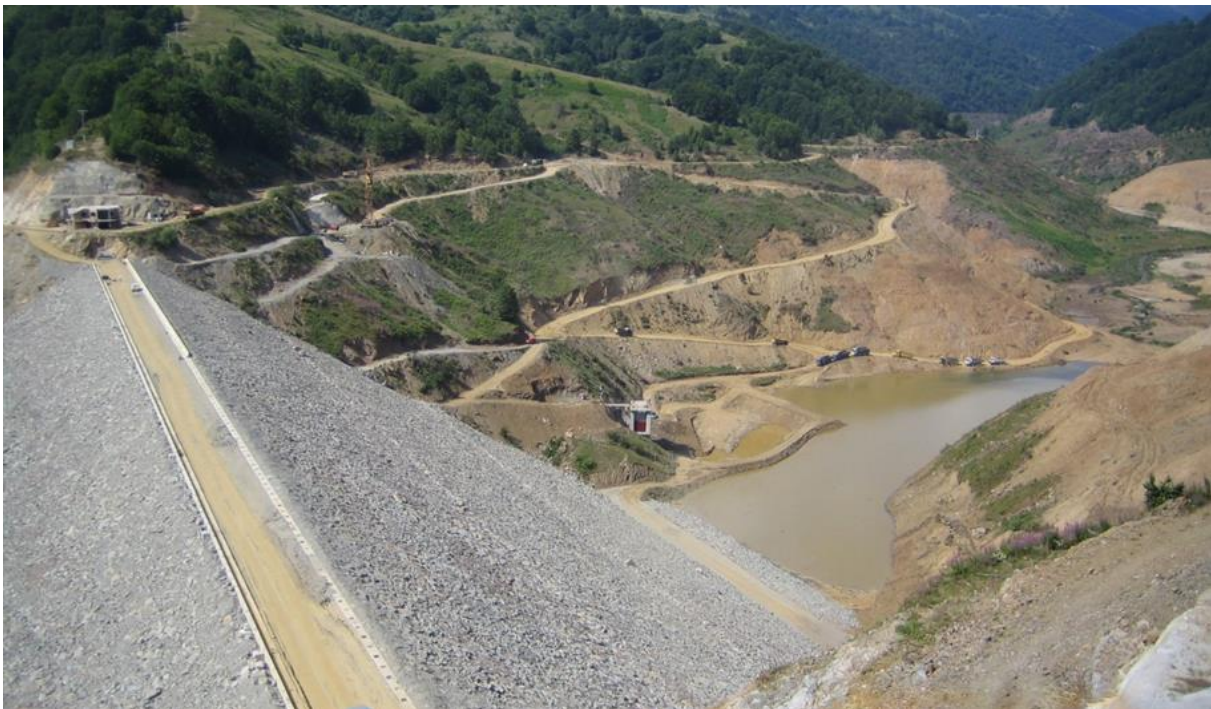
Knezevo Dam: late construction phase

In order to solve water-supply problems in six municipalities in eastern Macedonia, a major dam project was commissioned: the Knezevo dam. The rockfill dam is 75 m high and 300 m wide at the base. Its storage facility is 4 km long and it has a maximum accumulation of 23.5 million m³ of water.

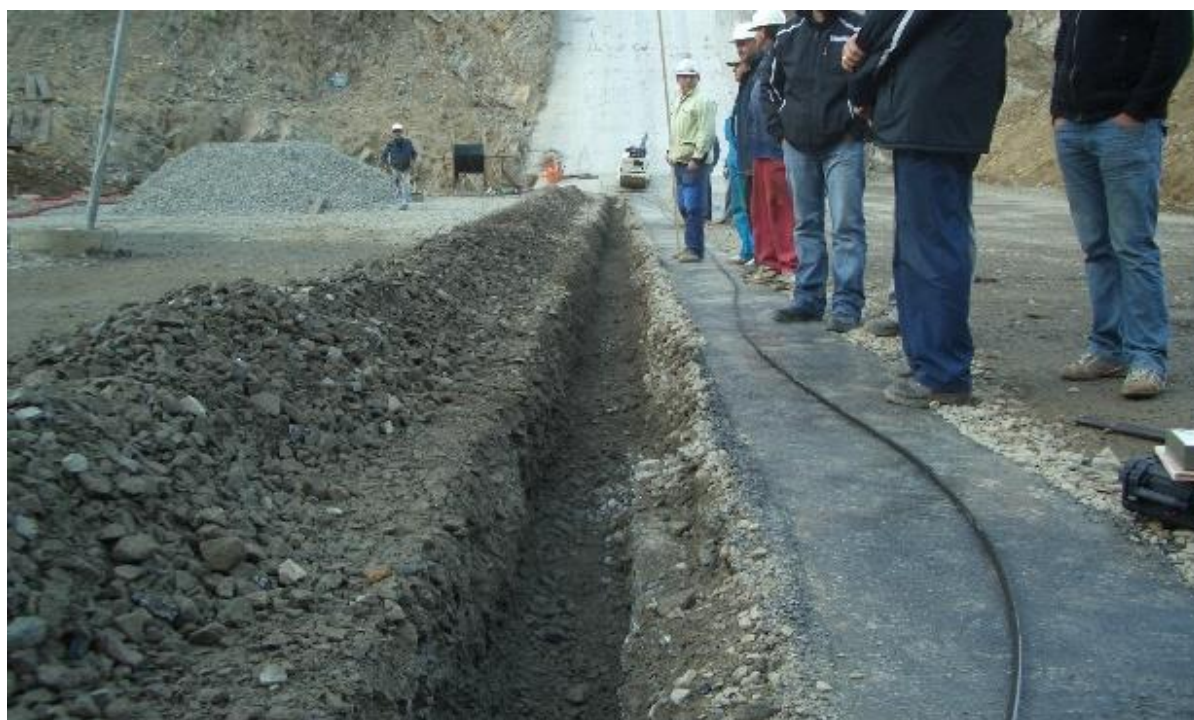
A dam of this size and importance needs to be monitored for leakage. The following diagram shows the most efficient pattern to use for the sensor cable layout. The cable was installed on the downstream side of the interior asphalt core, inside the filter zone.

Approximately 1,200 m of sensor cable was required. The type of cable selected was a hybrid sensor cable which utilizes multimode sensor fibers together with copper wires in the tube to facilitate controlled heating and cooling. In this case, the copper wires have about 11 W/M heat output and four heating cycles are carried out daily.

Cable installation

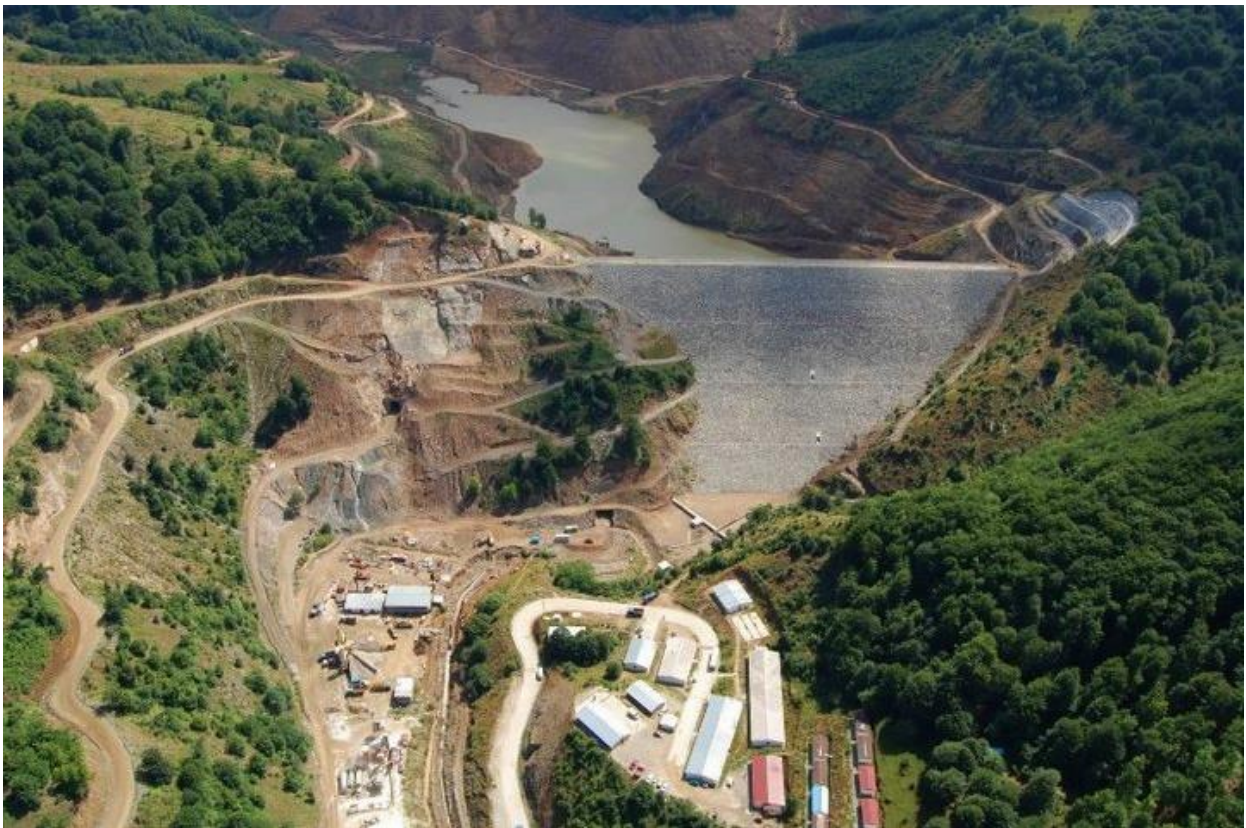
Knezevo Dam Overview
