CASE STUDY

Below Ballast Scan (BBS) in action

A Case Study Compilation

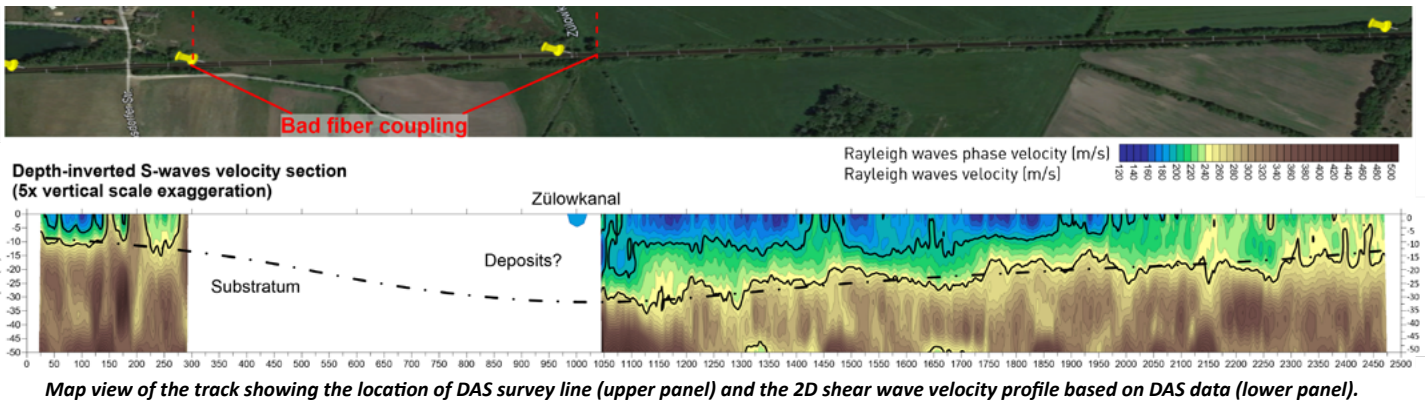
In this trial the analysis of shear wave velocity shows a general conventional trend of velocity increase with depth (from dark blue colour at the surface, indicating

soft rocks, to brown, indicating hardening). No danger zones were detected.

A BBS study was carried out as part of a collaboration between AP Sensing and Sercel to prove the value of the roadbed scanning solution. A 2.5 km section with different surface features and visible differences in geology (presence of lake, fields, rock outcrops nearby) was selected.

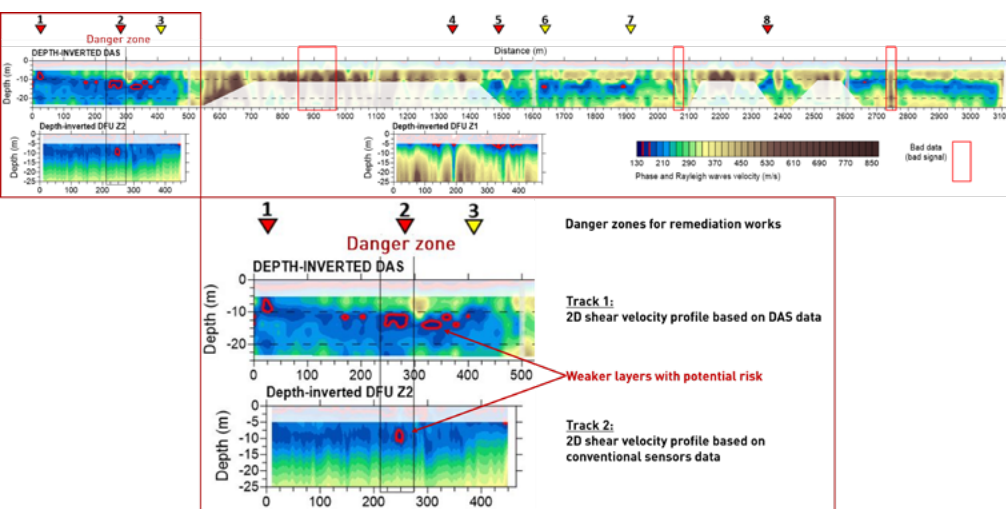
Seismic surface wave analysis along the track in Eastern Europe. The upper panel shows the entire ~3000m track length. The lower zoomed-in panel shows the first 500 m of the track with explanations.

A cargo train of one of the key railroad operators in Eastern Europe derailed because of ground subsidence. Traditional track integrity techniques could not provide proper subsurface evaluation with reasonable depth of investigation to identify the locations of sinkholes. Traditional blind drilling and subsequent cementing of sinkholes along a track more than 22 km long also could not guarantee a result. Therefore, to detect and cure hazard zones, Sercel performed nodal geophysical survey within 2

zones, each 500 m long.

In order to perform near surface characterization under the remaining problematic zone of the track it was decided to apply the BBS solution using a DAS system connected to existing buried fiber optic cables. DAS data interpretation provided exciting results giving a baseline understanding of underground geology.
